737 GRAPHITE COMPOSITE FLIGHT SPOILER FLIGHT SERVICE EVALUATION

FIFTH ANNUAL REPORT

MAY 1978 THROUGH APRIL 1979

Prepared under contract NAS1-11668 by
BOEING COMMERCIAL AIRPLANE COMPANY
P.O. Box 3707
Seattle, Washington 98124

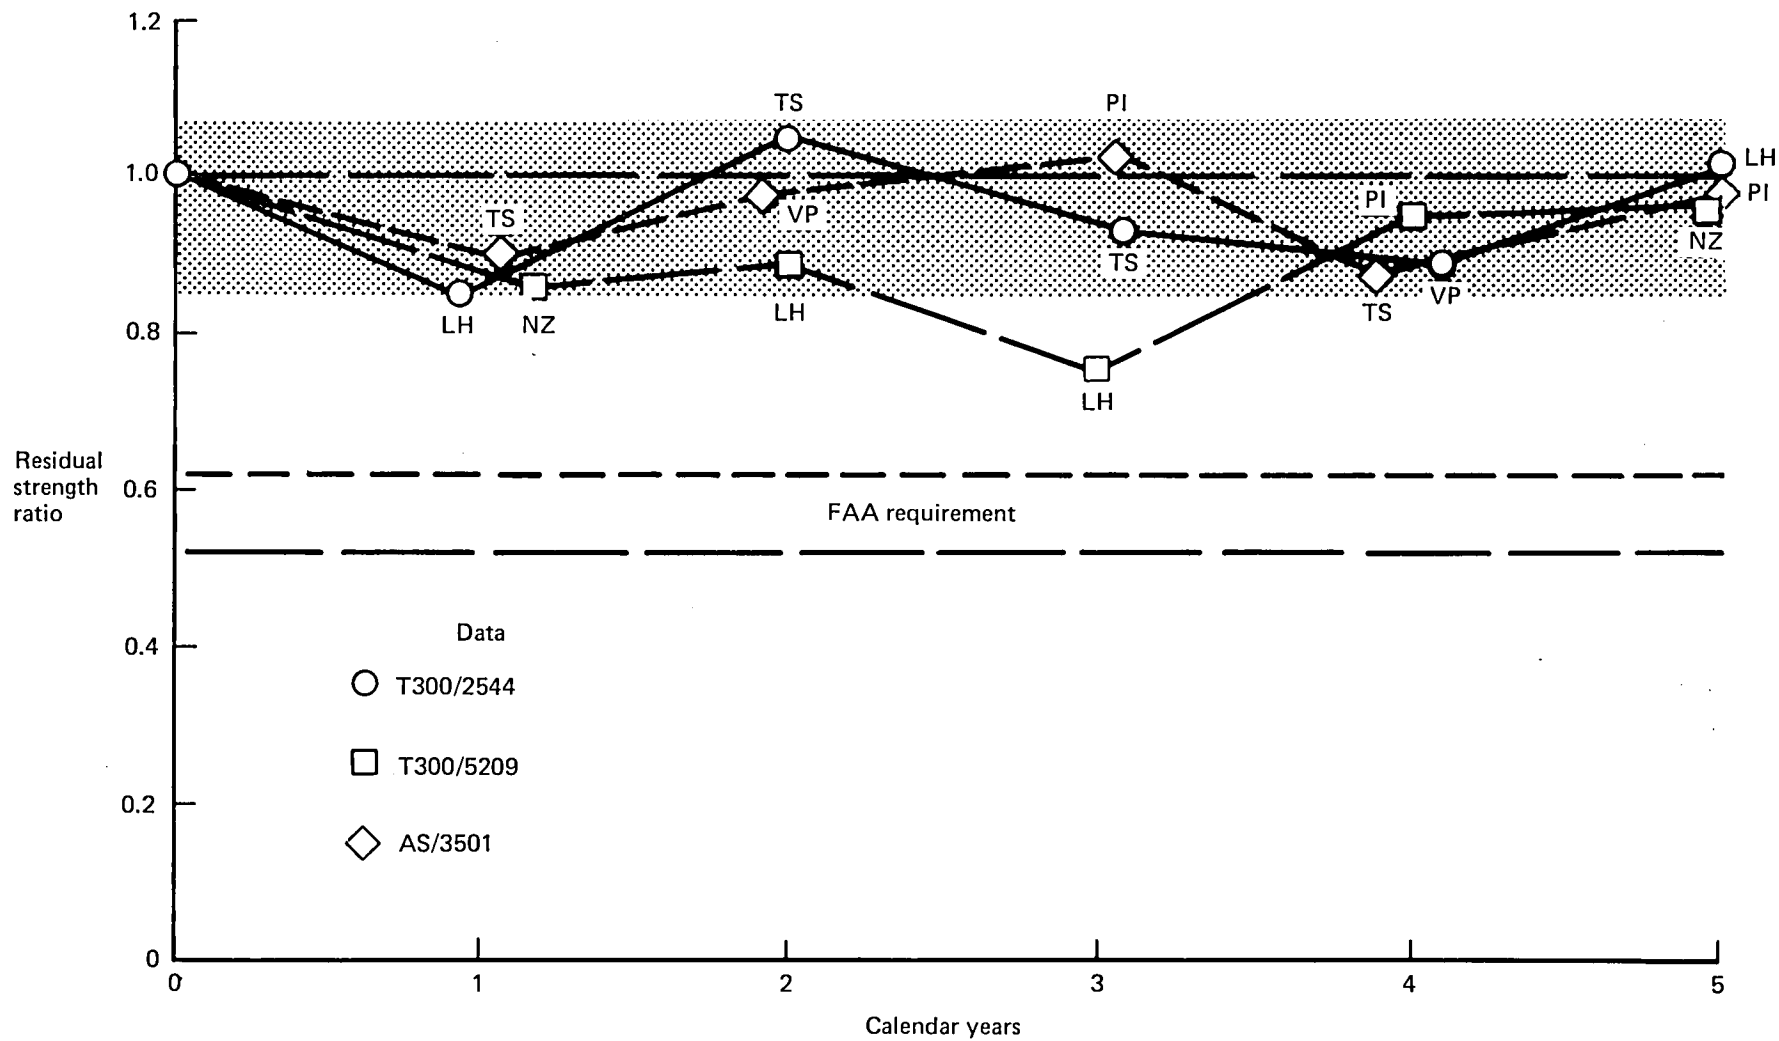
Figure 8.—Residual Strength After Exposure

A plot of the residual static strength data accumulated to date appears in figure 8, plotted as a function of time. This data continues to illustrate the data scatter previously discussed in reference 4. The 250°F curing resin system continues to perform well after reversing an earlier strength loss trend last year. Based on the available data, continued retention of static strength levels can be anticipated.

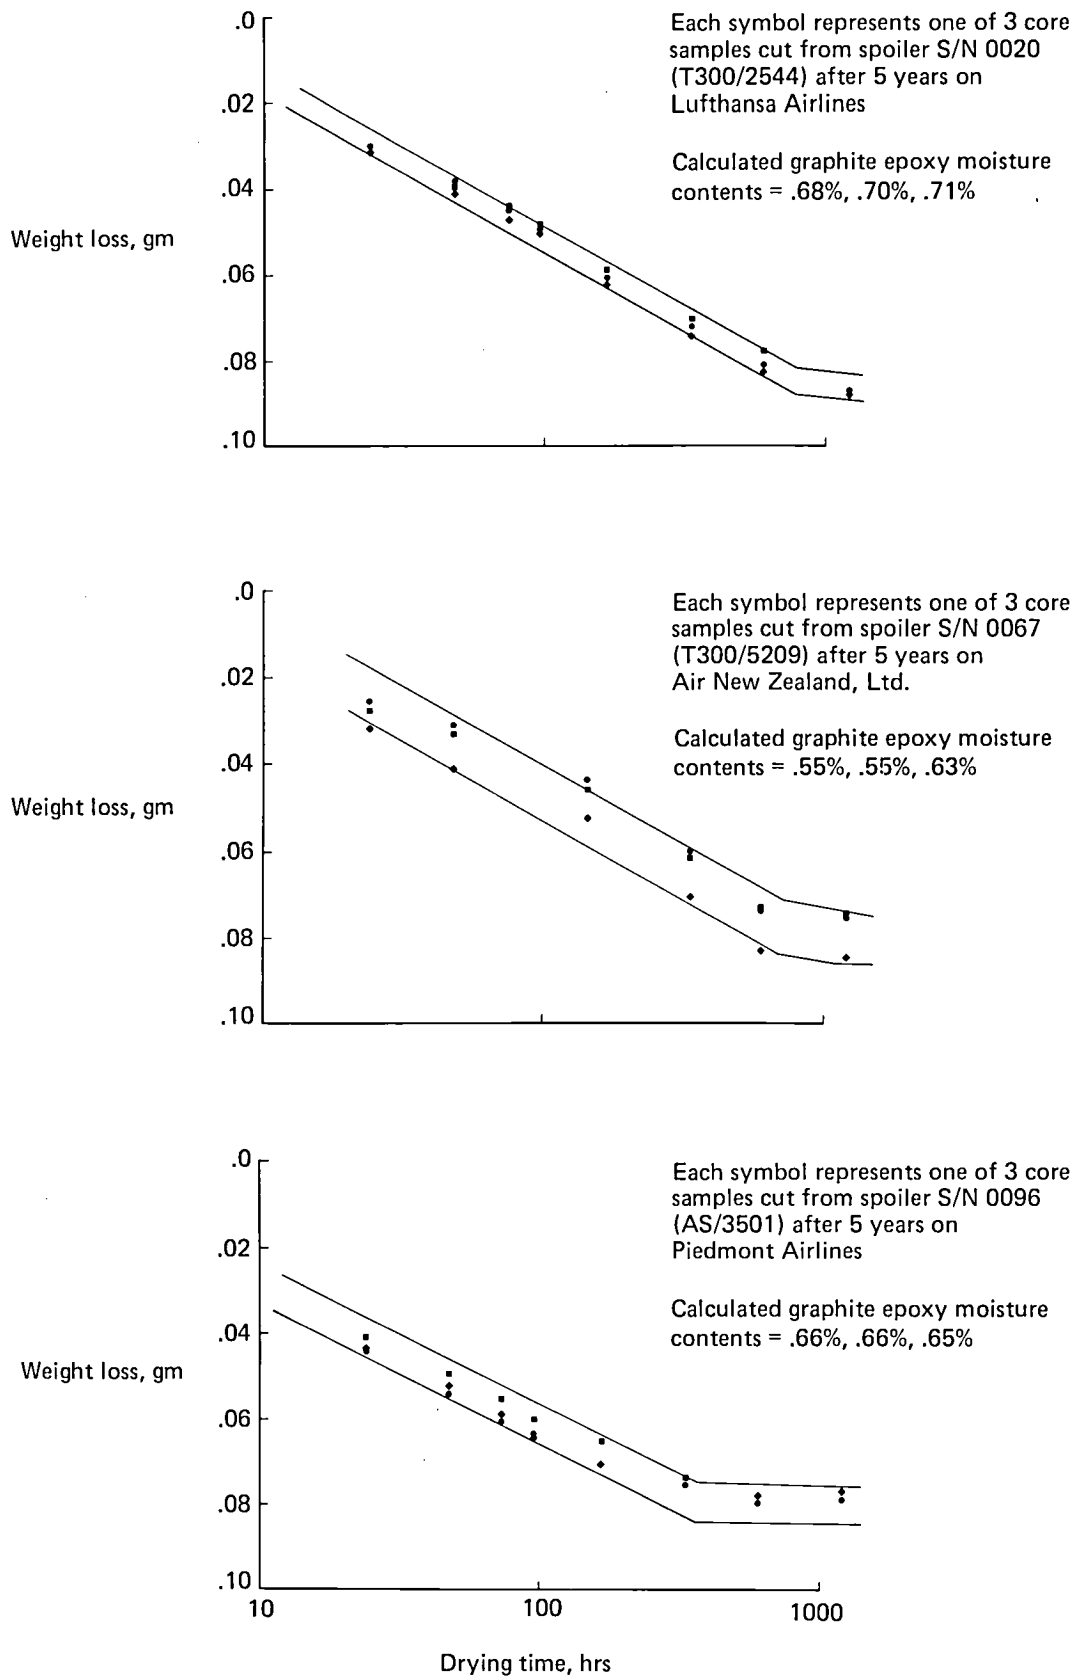
Figure 13.—Moisture Weight Loss of Spoiler Core Samples

All nine specimens were subjected to a 25-day drying environment at 160°F. The samples were weighed at discrete intervals in order to construct the weight loss curves shown in figure 13. In addition to the actual weight loss, a final observed graphite-epoxy moisture content has been calculated for each of the nine samples and is shown on the figure.

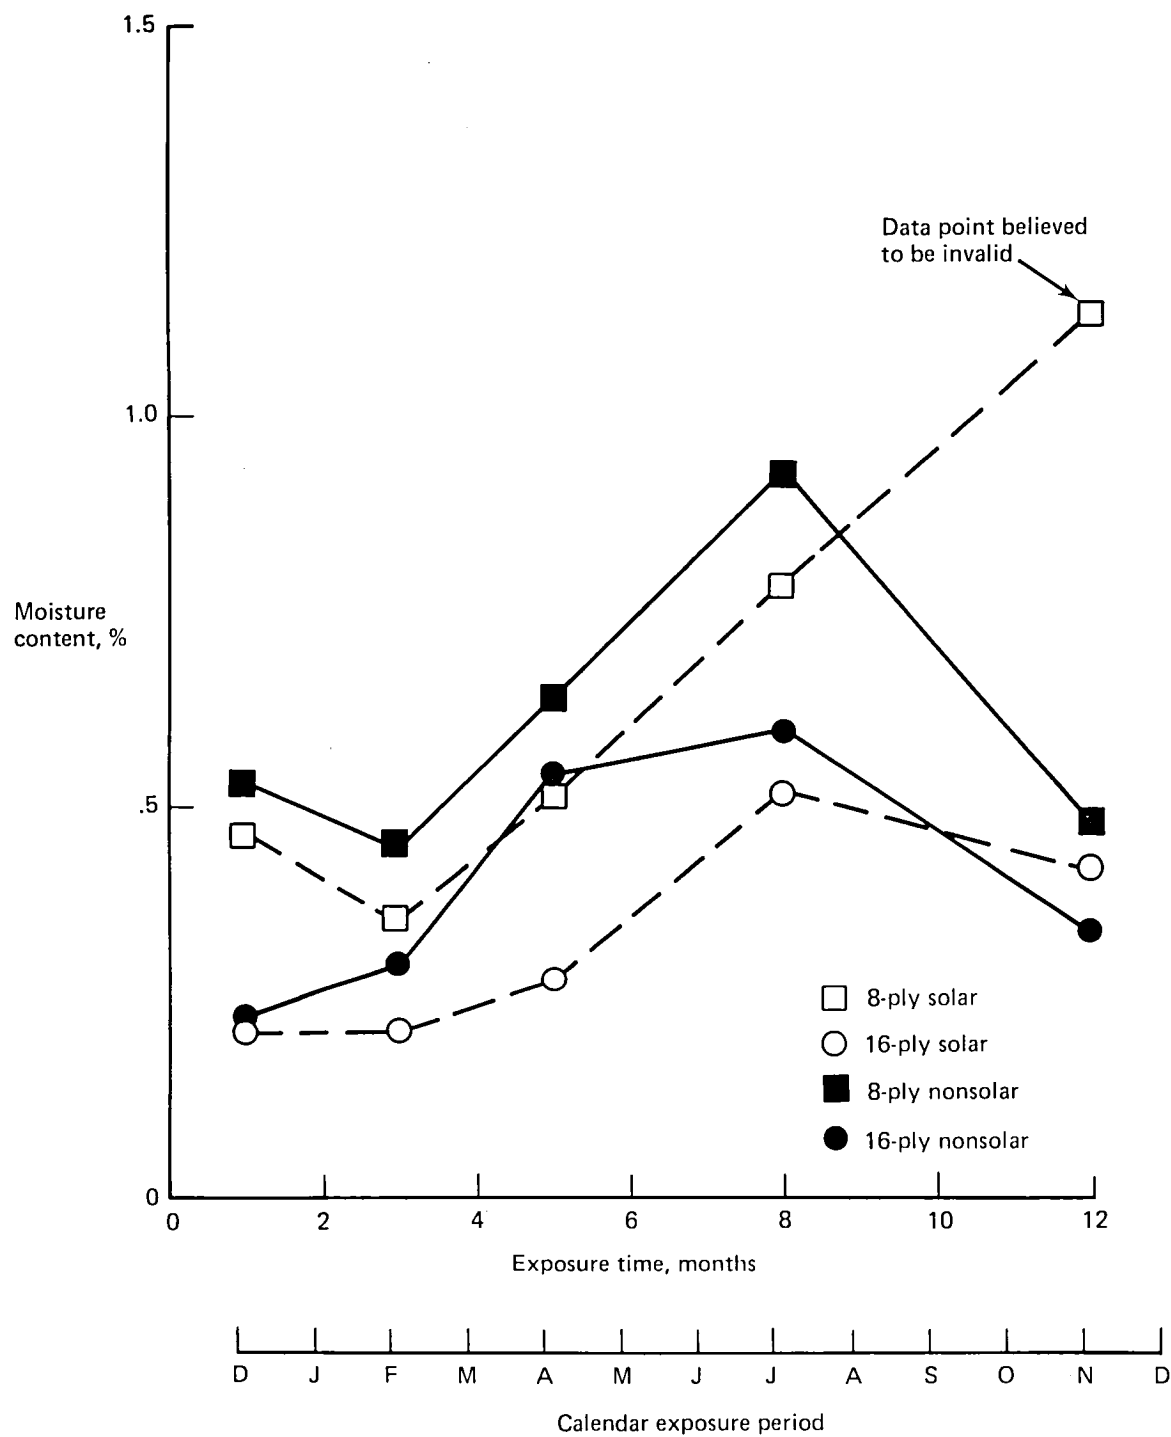
Figure 21.—Tailcone Coupon Moisture Content T300/5209 From Piedmont Airlines

Moisture content as a function of exposure time results are shown in figures 14 through 22. Each figure shows 8- and 16-ply solar and nonsolar exposure data for one material and one airline. In all cases data is shown for 5 times up to 12 months of exposure. Data shown for 12 month, 8-ply, solar, T300/5209 on Piedmont Airlines is believed to be in error due to an inaccurate baseline weight.

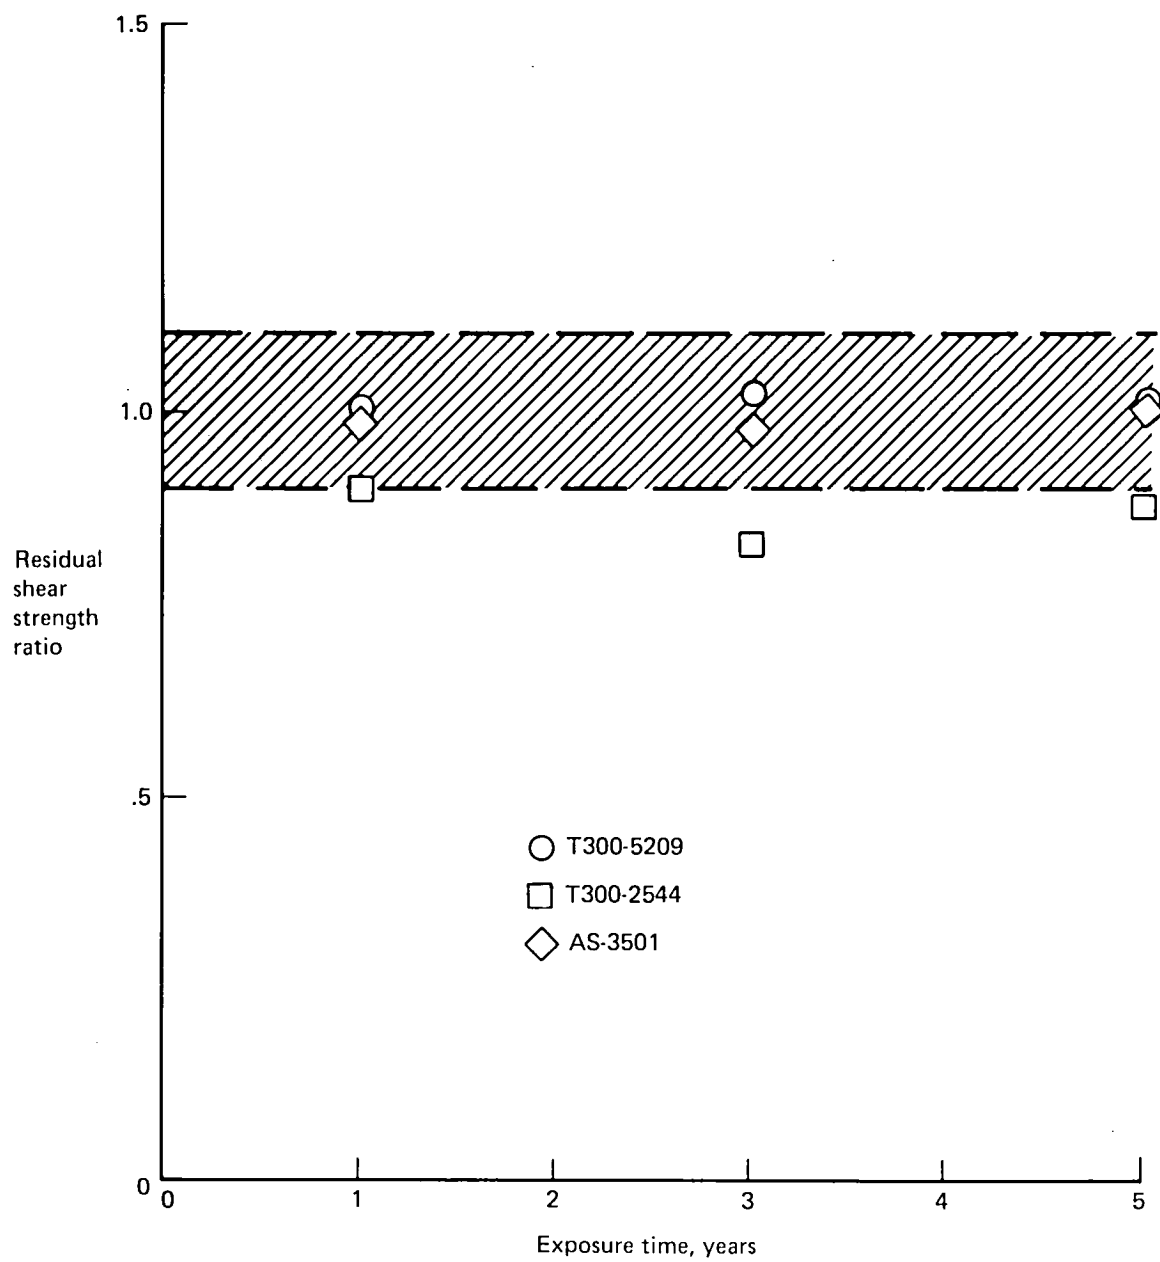
Figure 24.—Residual Shear Strength After Worldwide Exposure

The average residual strength ratios for the shear, flexure and compression specimens are plotted in figures 24, 25, and 26. These values represent a comparison of the average strength values for all six exposure sites with the average baseline strength value for that material system. A ± 10 percent bandwidth, which represents the strength scatter in the specimens with no exposure, is shown on each graph. The shear strengths of the T300-5209 and AS-3501 systems are fairly constant over the 5-year period, whereas the shear strengths of T300-2544 specimens have dropped below the bandwidth. The flexural strengths of all the materials are within the bandwidth except for the AS-3501 system, which shows a significant strength increase after 3 and 5 years' exposure. The compression strengths for all these material system—systems show a gradual decrease with increase in exposure time.
